DROITWICH JUNCTION LOCKS RESTORATION PLAN

DROITWICH JUNCTION LOCKS RESTORATION PROJECT PLAN

FUNDED BY THE IWA NEIL PITTS LEGACY

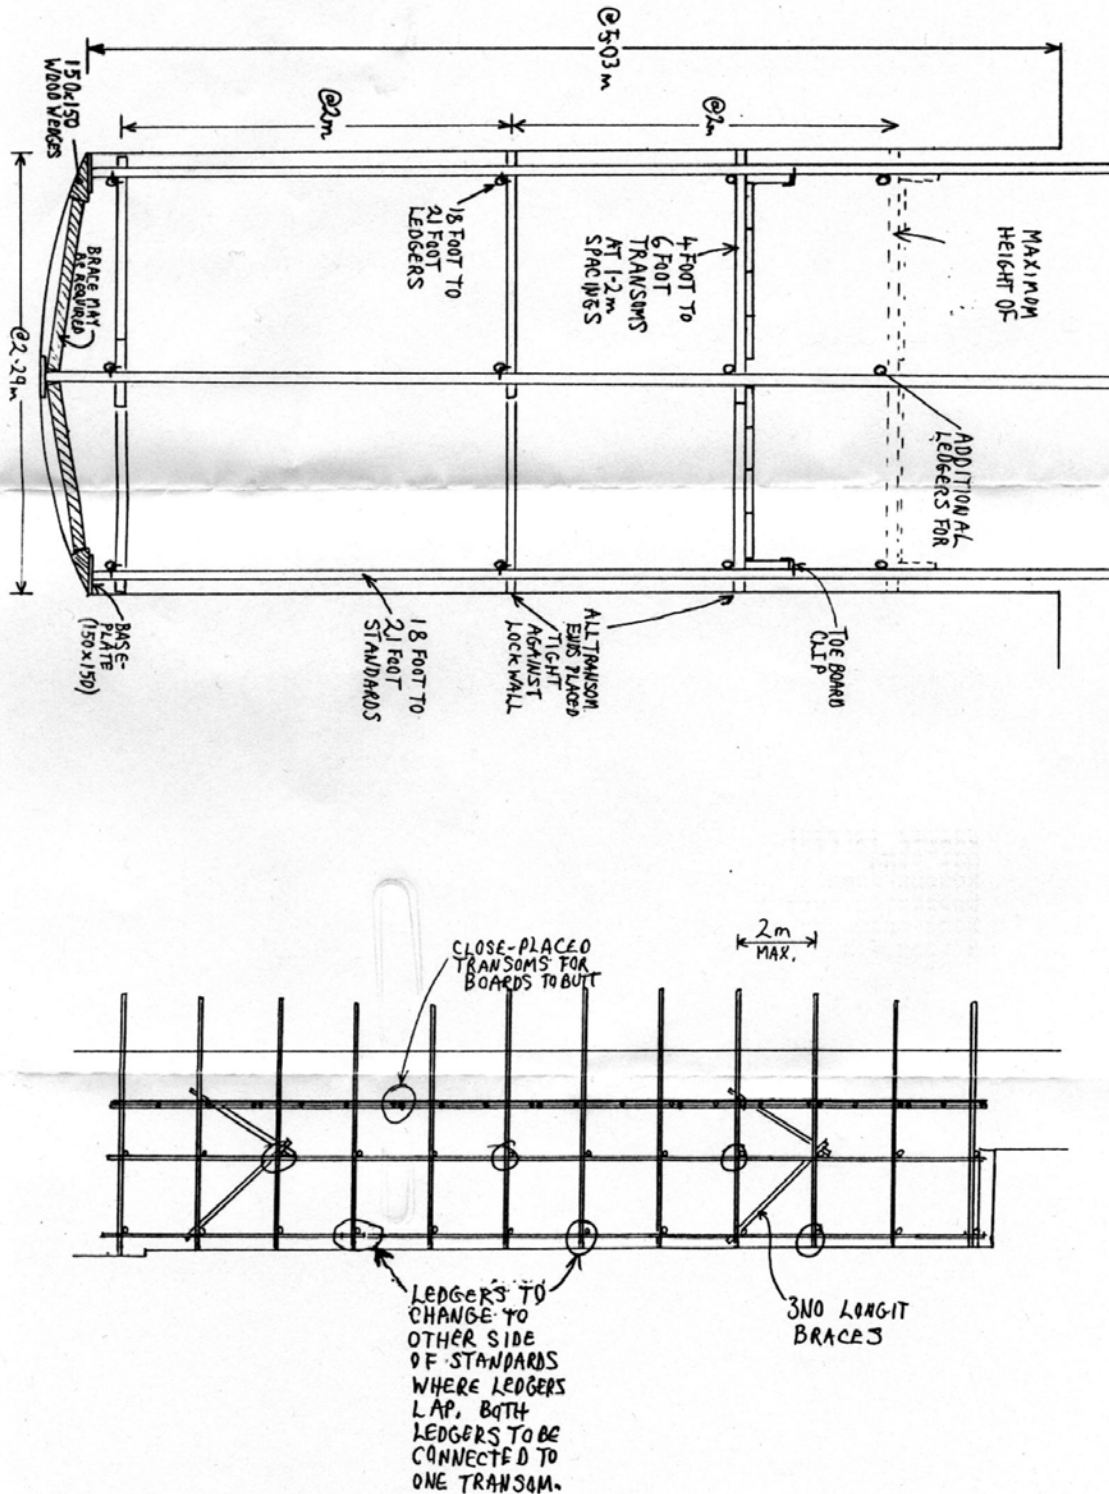
Inspection during demolition has revealed two stones on the towpath wall that are significantly damaged by vegetation growth. This has spilt/de-laminated both stones and resulted in severe disintegration of the underneath and rear of the stones. It has been decided that to attempt any repairs to these stones would be too dangerous using the method described above. To remove and clean up the brickwork beneath these stones would be likely to result in an uncontrolled movement that would not be stopped by the acrow props. Thus the two stones are to be left in situ and fenced off on the scaffolding

level. The rest of the walls will be rebuilt to solidify the rest of the structure. Once this is complete a decision on the two stones and the wall beneath them will be taken.
